**City of San Diego Photo
Enforcement System Review
Final Report**

City of San Diego Police Department

PB Farradyne Inc.

January 14, 2002

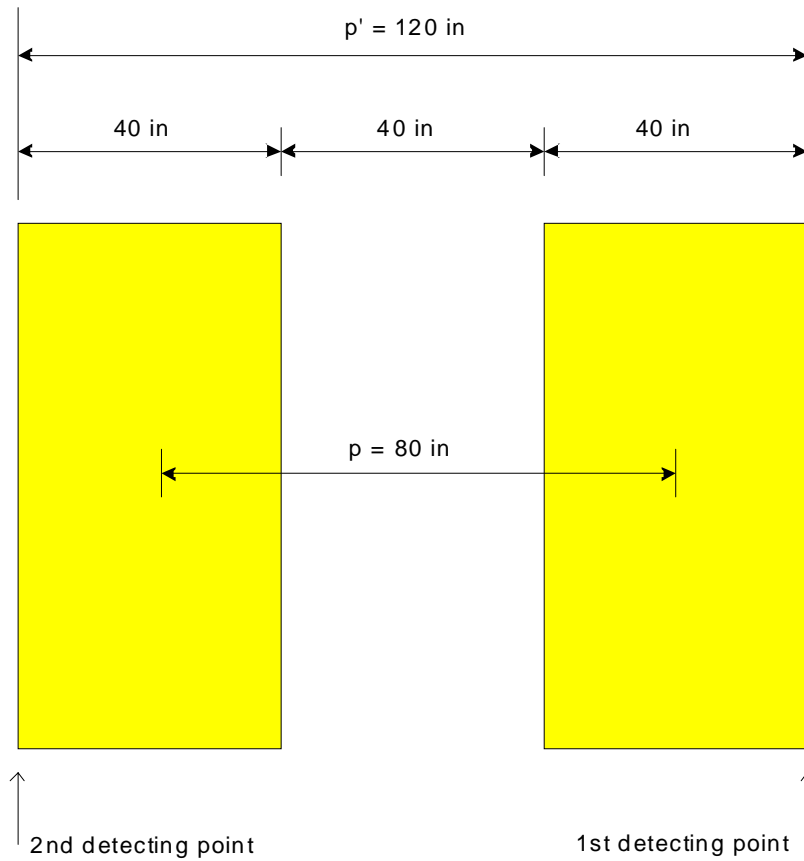
**Figure 3-1
LONG PITCH LENGTH ERROR**

Figure 3-1 illustrates a possible error condition where a vehicle is detected on the leading edge of the first loop and on the trailing edge of the second loop.. In Note that this error condition is possible but is not likely as evaluated this instance, the vehicle actually travels a distance of 120 inches, from the first loop to the second loop, but the camera unit calculates the vehicle speed based on a pitch measurement of 80 inches. This error results in the vehicle speed being underestimated.

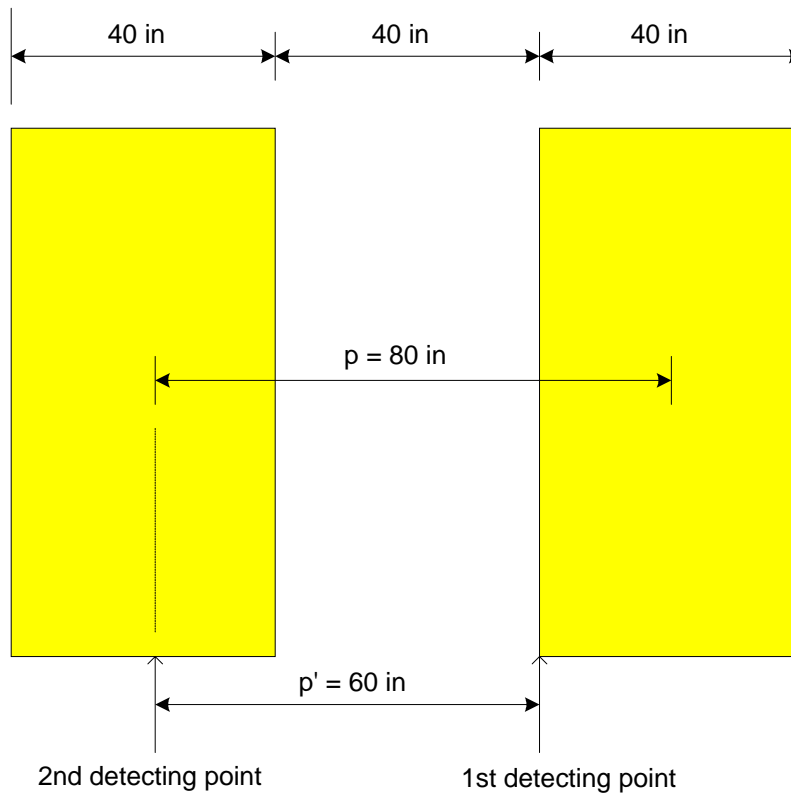
Figure 3-2
SHORT PITCH LENGTH ERROR

It is possible that a vehicle could be detected on the trailing edge of the first loop and at the leading edge of the second loop, meaning that the vehicle has only traversed a distance of 40 inches and that the vehicle speed would be overestimated by 100 percent. With errors of this magnitude, it is possible that motorists could be improperly cited. However, given that the vehicle detection loops are configured the same, this possible error condition is considered to be extreme and not applicable for this analysis.

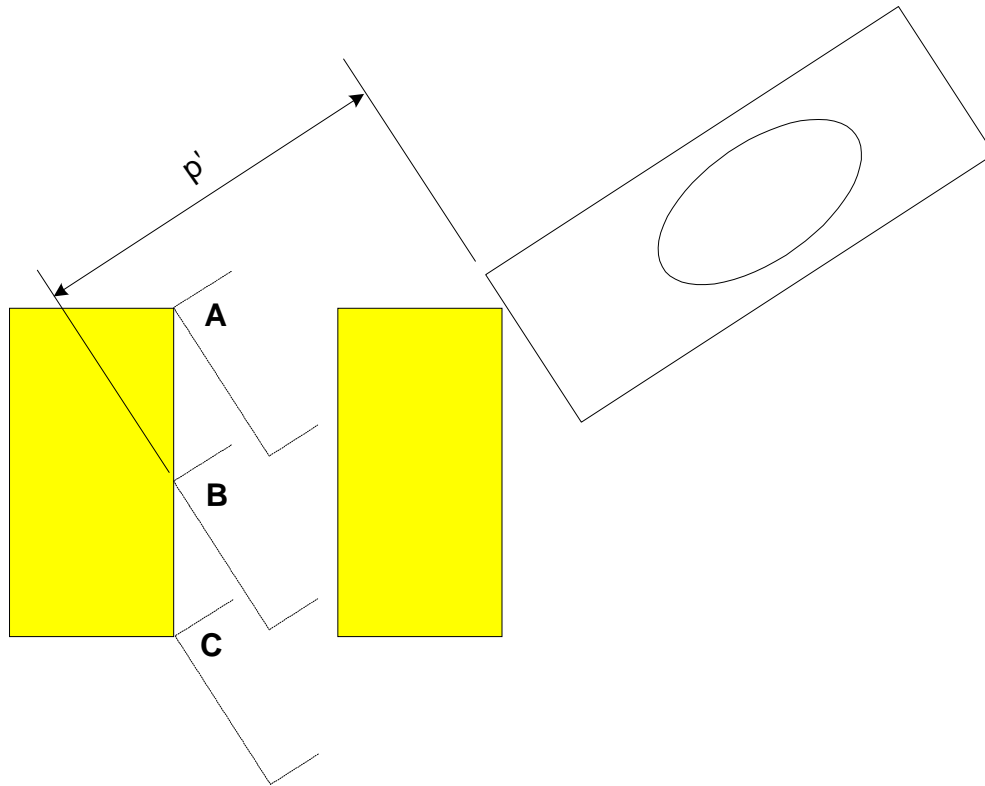
Figure 3-3
EXAMPLES OF POSSIBLE COSINE ERRORS

Errors referred to as cosine errors may occur when a vehicle passes the loops with an angle against the loop alignment axis as illustrated in Figure 3-3.

The actual pitch length (p') depends on the detecting point of the second loop (points A, B, or C in Figure 3-3). The minimum pitch length (p') occurs when the vehicle meets the second loop at point A while the maximum pitch length (p'') occurs when the vehicle is detected at point C of the second loop as illustrated in Figure 3-3.

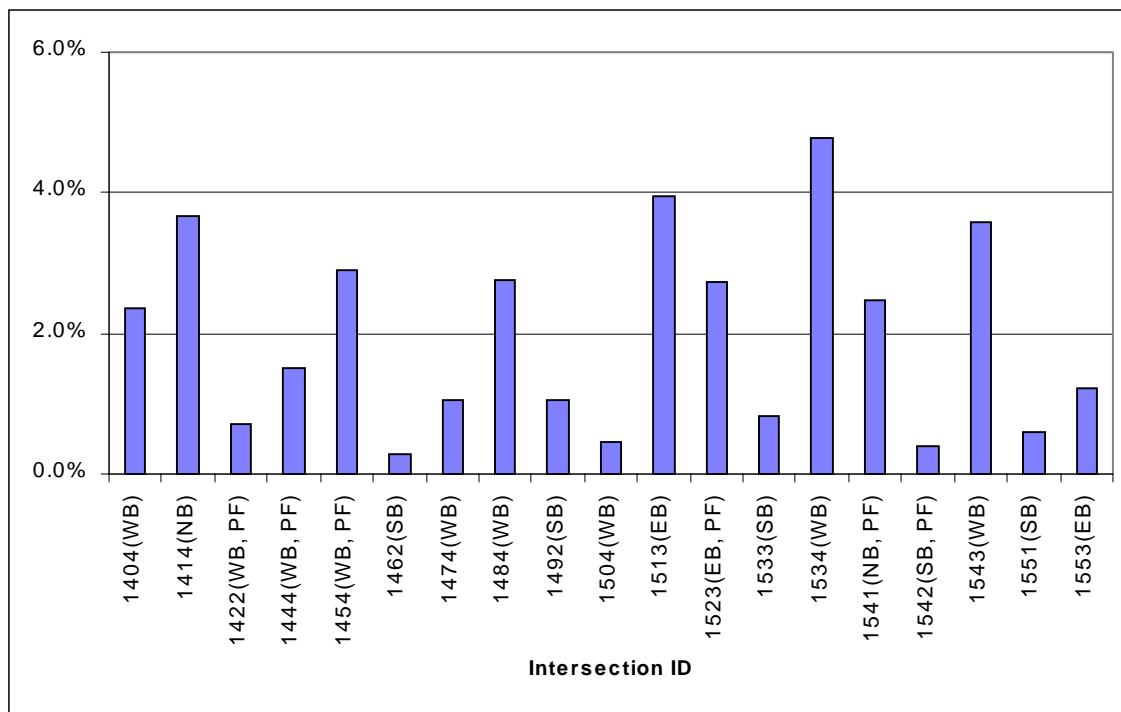
Figure 5-4
CITATIONS NOT ISSUED DUE TO WINDSHIELD GLARE

Windshield glare is caused by the sunlight reflecting off the windshield that prevents the camera view from penetrating the interior of a vehicle. Windshield glare is closely related to the time of day and the direction of vehicle movement as well as with the angle between the camera and the sun. Not surprisingly, the analysis of the windshield glare indicates that the percent of citations not used due to windshield glare is highly related to the direction of movement (see Figure 5-2). Of the nine photo-enforced intersections where the percent of citations not issued are greater than 2.0 percent, seven intersections are oriented westbound or eastbound and only two intersections are northbound. It is also noted that four of the intersections with the higher rates of citations not issued for windshield glare do not have cameras equipped with polarizing filters.

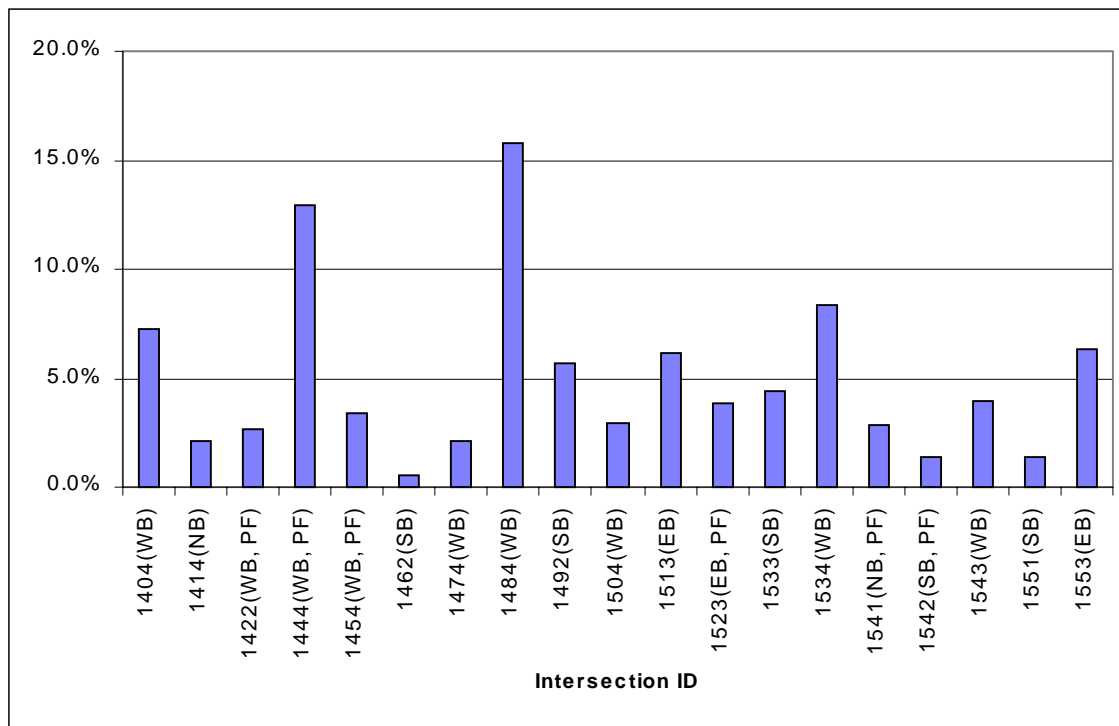
Figure 5-7
CITATIONS NOT ISSUED DUE TO POOR CLARITY OF DRIVER

The problem of poor clarity of the driver's face was the most common factor for not issuing citations, accounting for 8.5 percent of the total violations. California law requires that the driver's face be clearly visible in one of the photographs, usually the second photograph, in order for a citation to be issued. The direction of travel for the photo-enforced approaches at the intersections with the three highest citations not issued rates for poor clarity of the driver's face are either westbound or eastbound. None of the cameras at these intersections are equipped with polarizing filters.

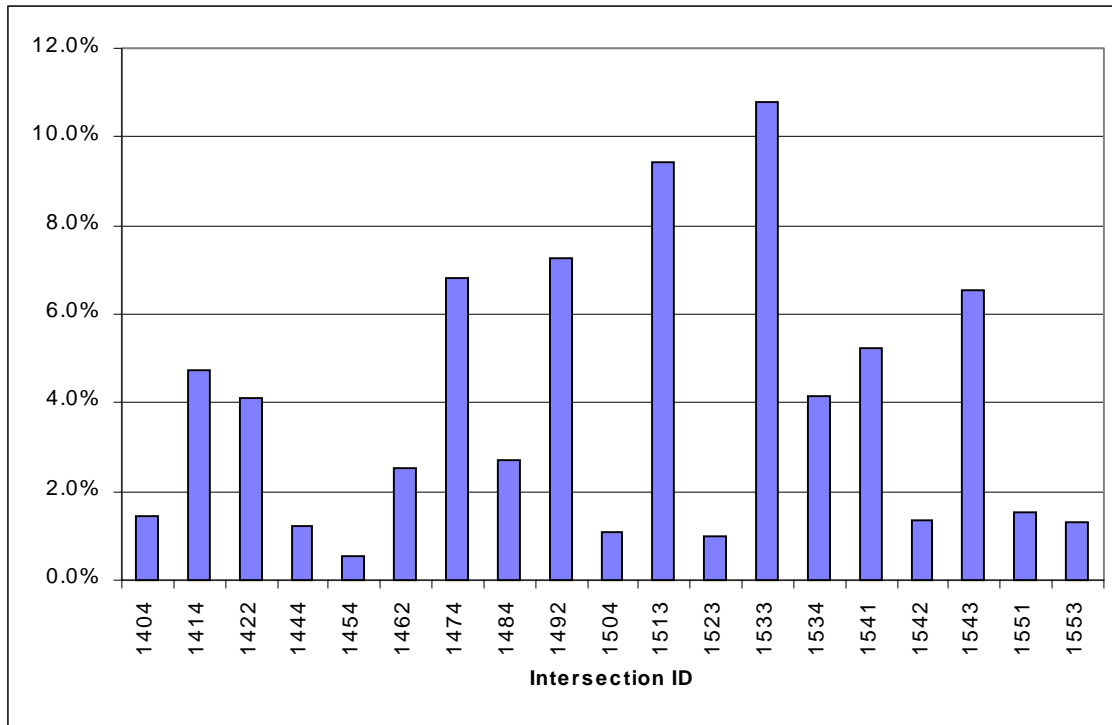
Figure 5-9
CITATIONS NOT ISSUED DUE TO LICENSE PLATE AND VEHICLE OBSTRUCTION

When the view of the license plate or vehicle is blocked by another vehicle further ahead in the intersection, it may not be possible to issue a citation. Obstructed views of the vehicle and plate occur more frequently at locations where left-turn movements are being enforced. Figure 5-7 shows that the intersections where the highest percent of citations not issued due to obstructed views of the vehicle or license plate are 1474, 1492, 1513, 1533, and 1543, all locations where left-turn enforcement is being done.

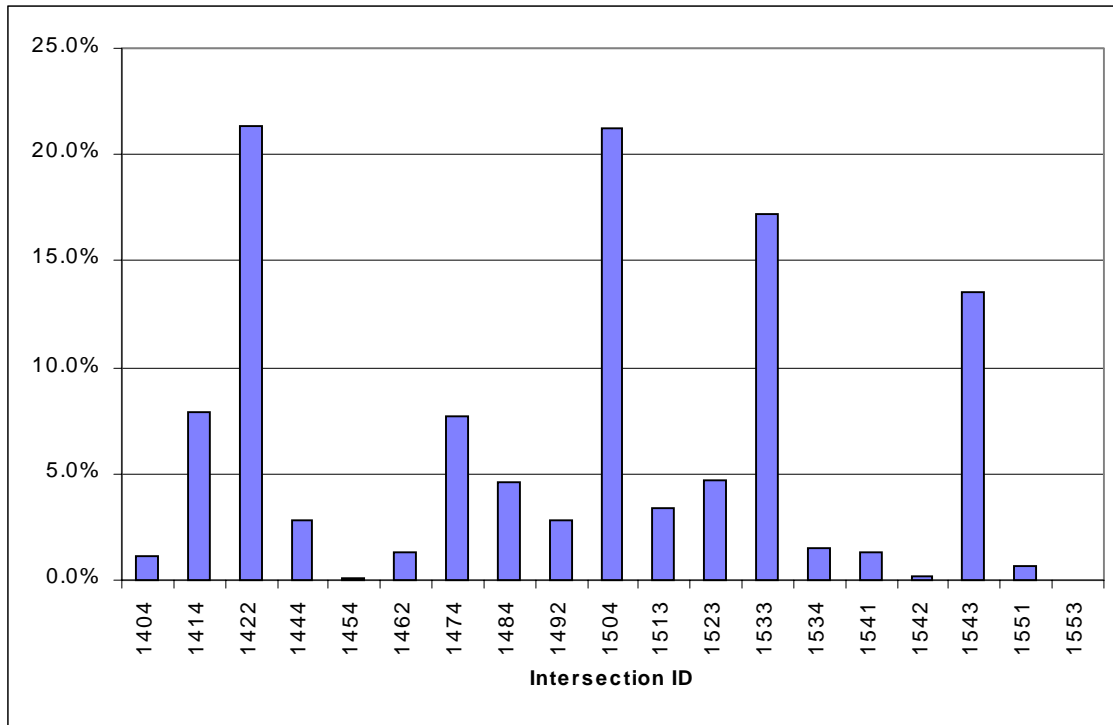
Figure 5-10
CITATIONS NOT ISSUED DUE TO FRAMING

The license plate, vehicle, or driver's face is outside of the frame of the second photograph. Poor framing may be caused by a camera lens with a focal length that is too long, poor camera angle alignment, or intersection geometric factors that result in motorists speeding up, making irregular turning movements, or being close to the camera when the second photograph is taken. Figure 5-7 shows the variations in the citations not issued for framing reasons by intersection.

Intersections 1422, 1533, and 1543 have experienced higher rates of citations not being issued due to framing problems. Enforcement at each of these intersections is for double left-turn lanes. For these locations, factors contributing to the higher rates of citations not issued are motorists speeding up as left turn movements are being completed (especially if being done against a red traffic signal), irregular turning movements, and a relatively shorter distance from the camera to the point where the second photograph is taken. Figure 5-8 summarizes the citations not issued data combined for obstruction and framing factors for this type of left turn lane enforcement, showing higher rates of citations not issued for left turns and left turns combined with through traffic enforcement.
