# **Analysis of High Collision Locations in San Leandro**

Prepared for:  
**City of San Leandro**  
Under  
**Traffic Engineering Technical Assistance Program  
(TETAP)**

**Dowling Associates, Inc.**

February 3, 2005

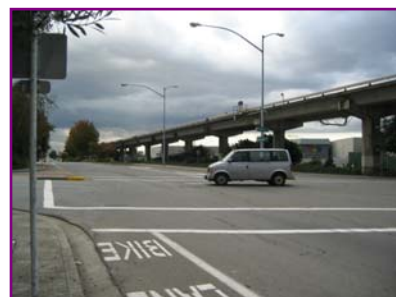
**Figure 2: San Leandro Boulevard Looking South Across Castro Street**

The San Leandro Boulevard / Castro Street intersection is unsignalized with stop sign controls on Castro Street. The six travel lanes (plus two bike lanes) on San Leandro are divided by a median. Many cars use Castro Street as an alternative to Williams Street causing traffic to backup especially during peak hours. The collision rate was 0.81 for the three-year period, with a total of 19 collisions, including one pedestrian-related incident and resulting in six injuries. All but four of the collisions took place during day light hours. Over three-quarters of the vehicle-to-vehicle incidents were right-angle collisions.

A possible cause of the collisions may be poor judgment of the crossing distance by drivers on Castro Street. This theory is supported by the fact that over half of the right-angle collisions occurred at the far side of the intersection. The remaining collisions mostly involved eastbound Castro Street traffic and northbound San Leandro Boulevard traffic, with poor sight distance considered a possible cause. High speeds on Castro Street and violation of stop controls may also contribute to the high collision rate. It was observed that some vehicles did not abide by the stop sign if there were traffic gaps on San Leandro Boulevard wide enough for more than one vehicle to cross.

It is recommended that the City prohibit through and left-turn traffic on Castro Street. In the short term, the City may put up Right-Turn-Only signs on Castro Street and provide law enforcement to reinforce the new restrictions. For the long term, the City may construct fully channelized left-turn pockets at the intersection if subsequent studies establish that Williams Street could carrier the traffic that is likely to be diverted.

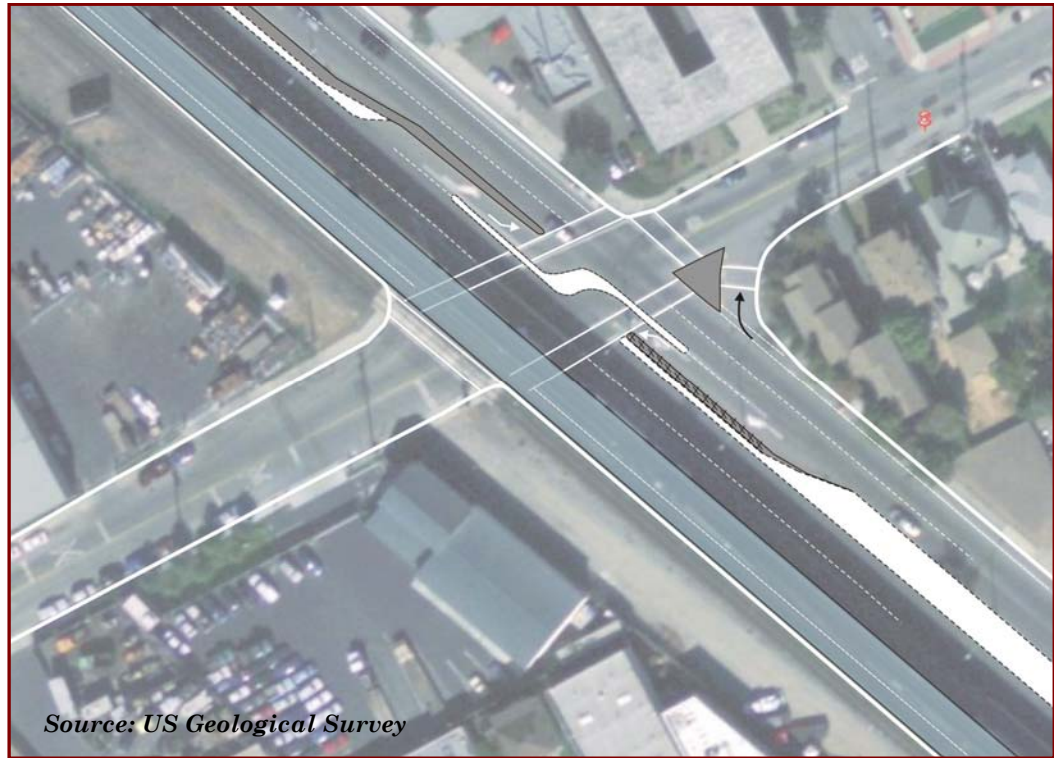
**Figure 4: Possible Configuration at San Leandro Boulevard / Castro Street**

One way to overcome the limitation of complete median closure and still achieve the desired result would be to construct fully channelized left turn pockets (an S-Shaped median) at the intersection. This type of median would allow left-turn movements from San Leandro Boulevard but cut off through and left-turn movements from Castro Street. Currently the southbound through lanes on San Leandro Boulevard measure a total of 28 feet wide (Figure 3). This area would provide enough room to construct a four-foot median and two twelve-foot lanes, as shown in Figure 4. The northbound lanes may be left untouched.

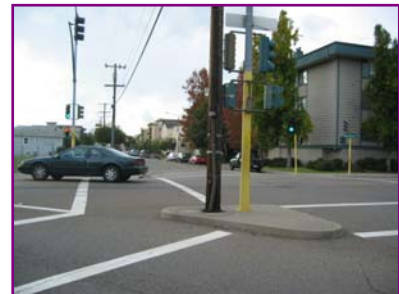
**Figure 5: Estabrook Street Looking West Across Washington Avenue**

The most distinctive feature of the Estabrook Street intersection is the presence of a small right-turn island at the southeast corner that houses an electrical pole as well as a pole where a set of traffic signals is mounted (Figure 5). This island is also used as a pedestrian refuge.

It is recommended that the existing traffic signals at the three intersections be put on blinking red flashes to indicate stop control for a period of three months as an interim measure. After the test period, City staff should review the collision data during the trial period and determine if permanent stop signs should be installed. If so, the traffic control at the three intersections should be changed to all-way stop signs.

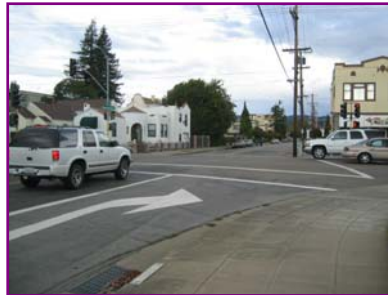
**Figure 6: Castro Street Looking East Across Washington Avenue**

eastbound traffic. Most of the collisions over the five-year period were results of unsafe driving speed, violation of traffic signals, and improper maneuvers.

At a recent site visit during non-peak hour, it was observed that some vehicles followed closely when traveling on Washington Avenue, showing signs of impatience behind slower moving vehicles on the two-lane street.

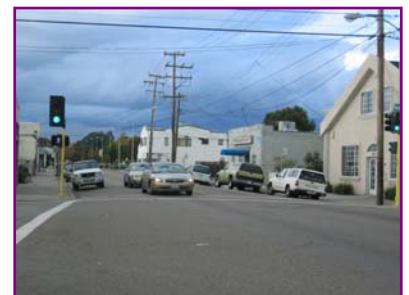
**Figure 7: Washington Avenue Looking North Across Williams Street**

The northernmost of the three Washington Avenue intersections, the east-leg of the Williams Street intersection is an eastbound one-way street. Williams Street at Washington Avenue ranked tenth with a collision rate of 0.53 and had a total of six collisions during the three-year period. One of the collisions resulted in injury. Unlike other intersections, a distinct pattern to or cause of the collisions could not be surmised. Additional data from the preceding two years are also inconclusive.

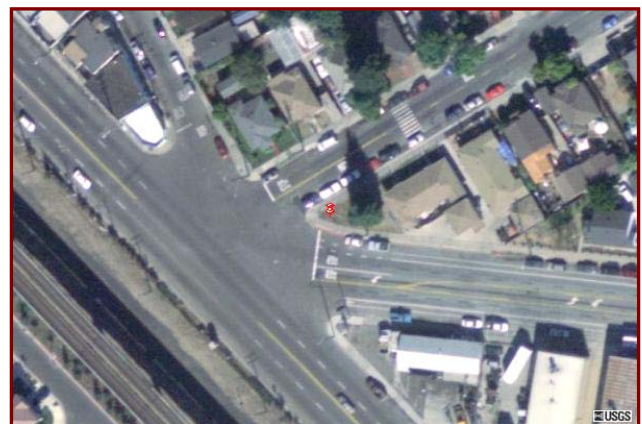
**Figure 9: San Leandro Boulevard/W. Broadmoor/Park/Apricot**

Sight distance has been identified as a problem at this intersection. The intersection setback requires minor street vehicles to move into the intersection to obtain better sight distance of vehicles traveling on San Leandro Boulevard. It is difficult for left-turning vehicles on Apricot Street to see vehicles traveling southbound on San Leandro Boulevard without moving well into the intersection and into the line of northbound traffic. The same is true for traffic on Park

Street. Sight distance is obstructed by the building at the corner of San Leandro Boulevard and Park Street. The openness of the intersection creates uncertainty for motorists at the intersection because of the limited sight distance.

It is recommended that turning movement counts be conducted and additional study be conducted for San Leandro Boulevard, Park Street, West Broadmoor Boulevard, and Apricot Street. If the additional study indicates that the semi-roundabout (Alternative 4) is recommended, surface mounted curb, temporary barriers, pavement markings and signing may be installed to test the alternative. If the test proves to be successful, a permanent semi-roundabout may be installed. If the additional study or the test operation of the semi-roundabout is not successful, one of the other alternatives may be considered.

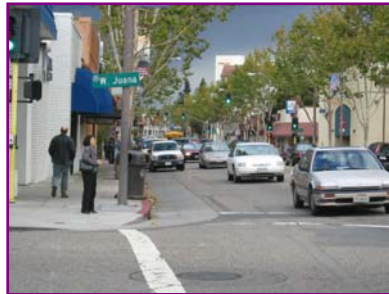
**Figure 17: E. 14<sup>th</sup> Street Looking North Across Juana Avenue**

The Juana at E. 14<sup>th</sup> intersection experienced the highest number of pedestrian-vehicle collisions during the studied period among the analysis intersections. Pedestrian safety is clearly a concern that should be addressed. The lack of left-turning pockets and protected phasing may also cause right-of-way confusion among motorists at this busy intersection and may have contributed to the collisions that involved left-turning movements.

Because retiming signal splits are the least costly to implement and may help reduce collision rate, it is recommended that the City apply leading pedestrian intervals at the Juana at E. 14<sup>th</sup> intersection as a first step measure to improve safety for pedestrians and motorists.

If this measure alone proves to be insufficient, the City may elect to create a left-turn lane on E. 14<sup>th</sup> Street by removing the parking lane on the west side of the street. However, the City may first work closely with downtown merchants and conduct a parking study to understand the supply and demand of parking in the downtown area and to identify alternative parking spaces as replacement if necessary.

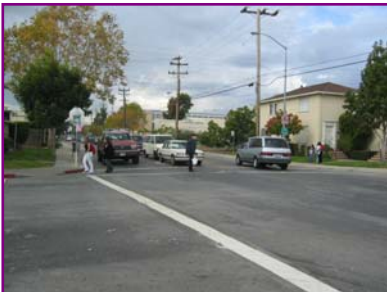
**Figure 18: Bancroft Avenue  
Looking North Across  
136<sup>th</sup> Avenue**

Bancroft Avenue and 136<sup>th</sup> Avenue are both two lane roadways controlled by all-way stops at their intersection. The intersection is near a major point of access to San Leandro High School. Therefore, foot traffic is particularly heavy immediately before and after school. At the same time, vehicular traffic is also heavy between 2:00 pm to 2:45 pm on Wednesdays and between 3:00 pm to 3:45 pm the rest of the weekdays due to after school pickup. It is common that traffic backs-up on both approaches on Bancroft and on the eastbound approach on 136<sup>th</sup> during this time as cars yield for pedestrians. The intersection meets traffic signal warrant for pedestrians.

Although no pedestrians were directly involved with the collisions, a majority of the collisions may possibly be attributed to pedestrian traffic and unsafe driving speed according to the City of San Leandro's traffic sergeant and collision data. Improvement measures at this location may involve traffic warning and traffic calming techniques.

It is recommended that incremental measures be implemented to improve collision rate at the intersection. The following devices may be installed in the following order:

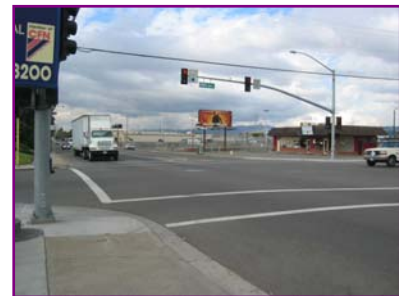
**Figure 22: Williams Street Looking South Across Doolittle Drive**

A total of twelve collisions were reported during the three-year period. Four of the collisions involved southbound left-turning movements and two westbound left turning movements. There were three right angle collisions and three rear-ended collisions. Available data are not sufficient to pinpoint engineering deficiencies at this intersection though the lack of protected left-turn phasing might be a contributing factor to the high collision rate.

It is recommended that further studies be conducted on truck traffic volume, delay, and turning movement volume in order to determine the applicability and potential effectiveness of implementing protected left-turn phases at the intersection of Williams Street and Doolittle Drive. Such studies would also provide additional information for further improvement measures development.
