Metro Orange Line Speed Evaluation Study

Final Report

Contract Number PS4010-3041-DD-04 (Discipline 4)

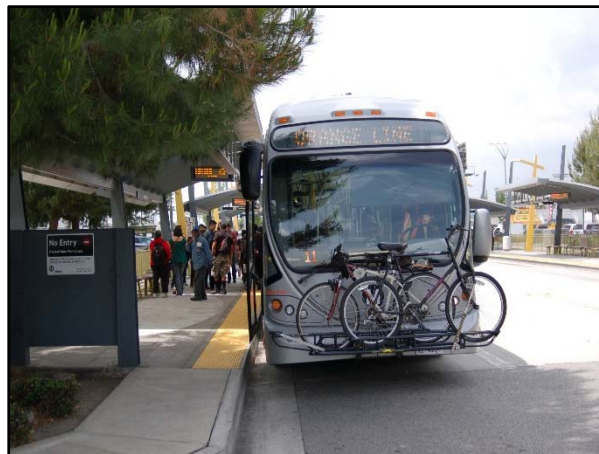
Exhibit 1: High ridership during peak hours, including bicycles and wheelchairs

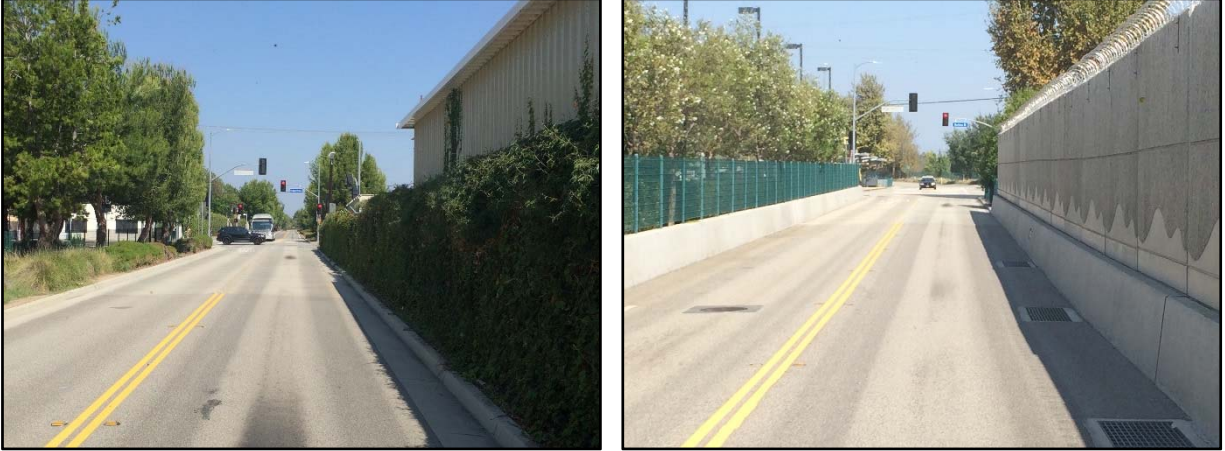
Exhibit 2: Sight distance constraints due to landscaping, buildings, and walls

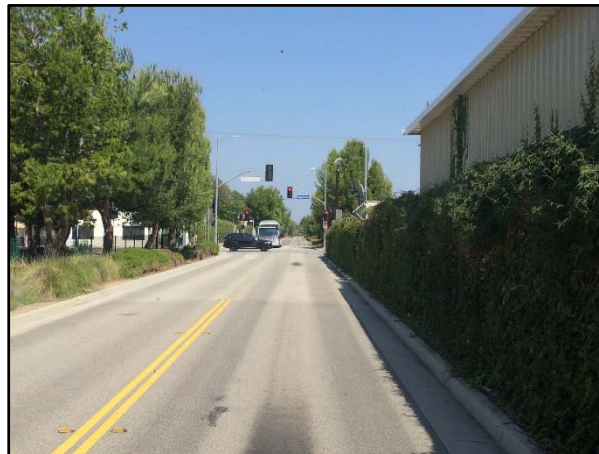
Exhibit 4: Sight distance constraints at intersection crossing

- 1) Uncertainty of cross-traffic activity when approaching a crossing, as shown in **Exhibit 4**:
 - A history of collisions, as well as observed intrusions into the busway by vehicles, bicycles, and pedestrians, creates a general sense of uncertainty for bus operators as to whether the intersection will be clear. It is important to note that this uncertainty is certainly not unique to the Orange Line busway when looking at all Metro bus routes in the greater Los Angeles area.
 - Sight distance constraints, limited by landscaping, adjacent soundwalls, or structures, can further exacerbate the sense of uncertainty at certain crossings.

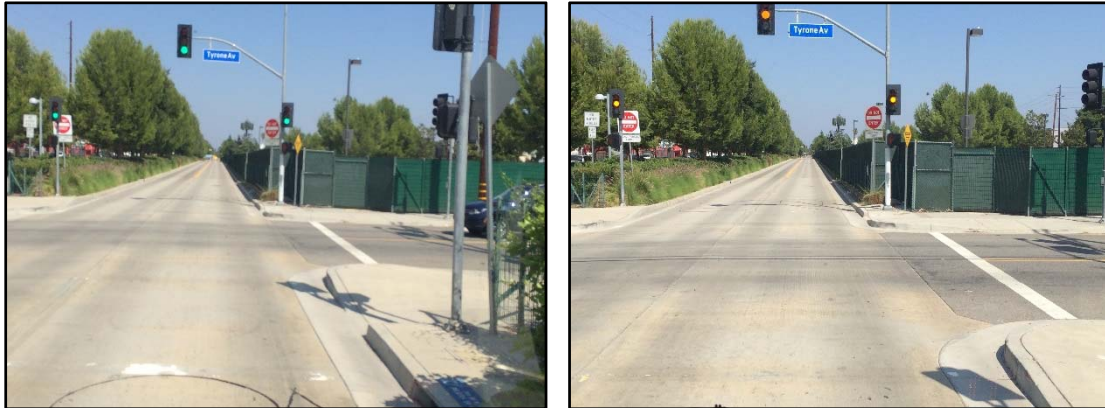
Exhibit 5: Traffic signal changes from green to red as bus approaches intersection

- 2) Signal timing at crossings:
 - Traffic signal timing operations also create a sense of uncertainty for bus operators. The more seasoned operators are familiar with existing signal timing and phasing, and can modulate bus approach speeds to maintain forward motion without having to come to a complete stop at red lights. For more junior operators, it is clear that the signal operations are not apparent. During many line rides, consultant team staff observed signals changing from green to red as the buses approached, as shown in **Exhibit 5**.

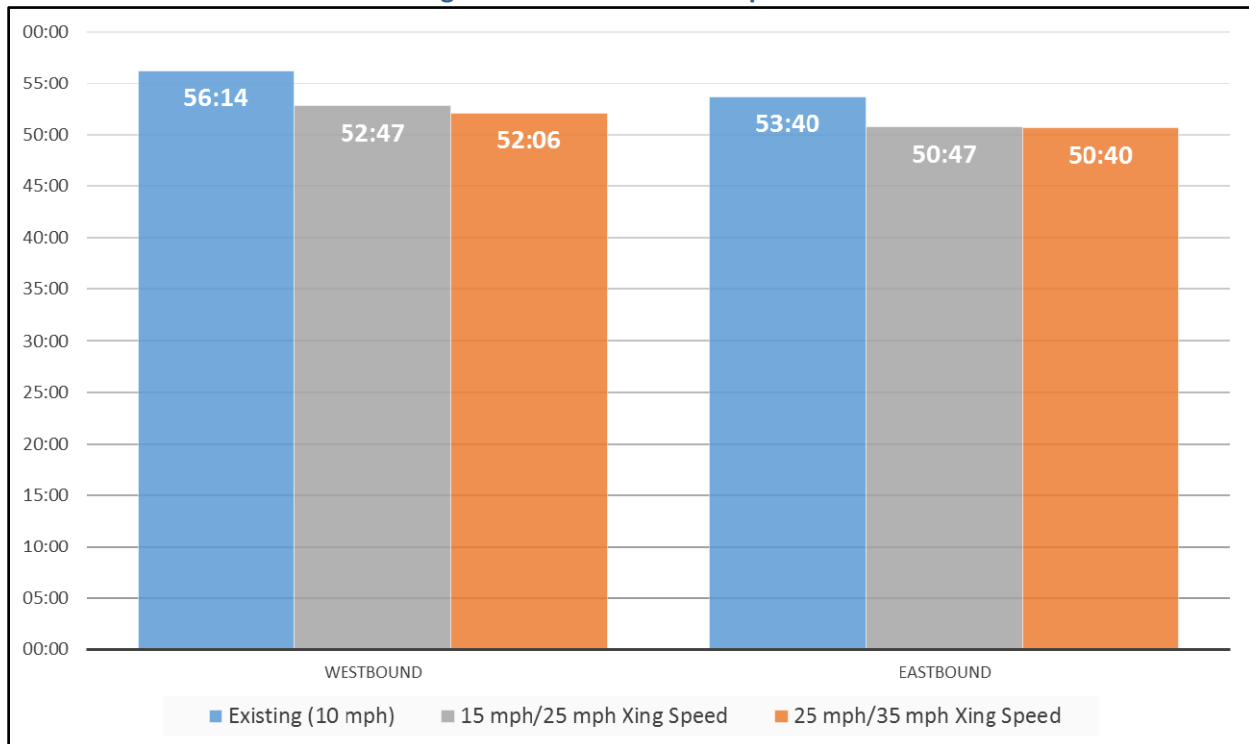
Figure 7 – Travel Time Comparison

As shown in **Figure 7**, the “Immediate” scenario shows a maximum travel time savings of approximately three and a half minutes, while the “Recommended” scenario provides travel time savings of over four (4) minutes.

Figure 7 below presents a summary of the modeled travel time along the entire alignment, under the three scenarios described above.
