**City of San Diego Photo
Enforcement System Review
Final Report**

City of San Diego Police Department

PB Farradyne Inc.

January 14, 2002

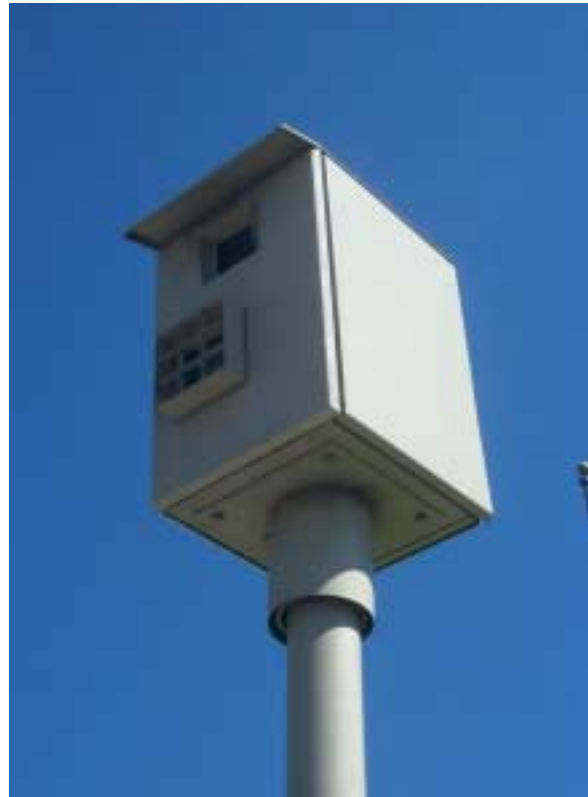
**Figure 4-2
CAMERA HOUSING**

The camera pole (See Figure 4-1) and housing (See Figure 4-2) were visually examined to determine the type and condition of the unit. In addition, the pole model was obtained from the LM/ACS representative.

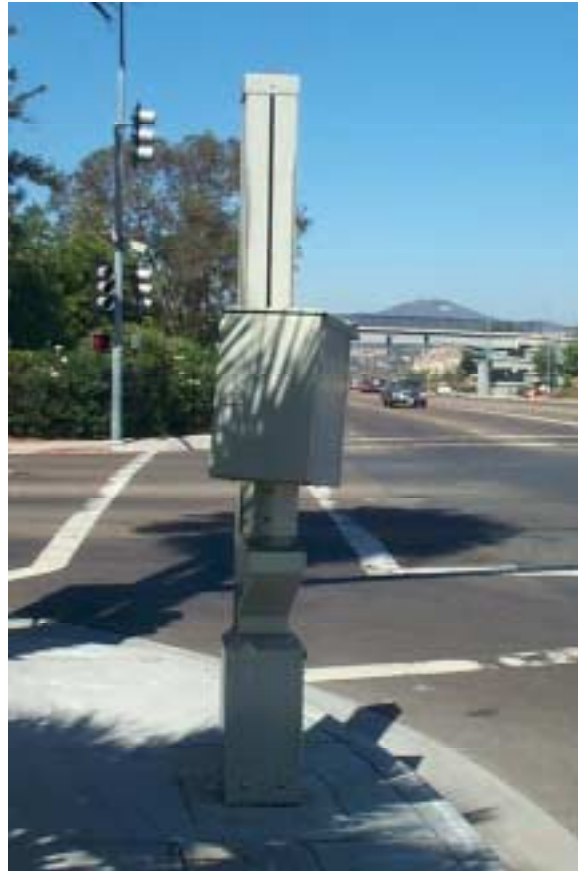
Figure 4-5
LOWERED ELEVATOR POLE

Three different camera poles (models 200, 300, and 400) were found at the 19 locations studied in this evaluation. Of these three models, the 200 model pole is the oldest and most frequently used model used at the 19 photo-enforced intersections. The model 200 pole is unique from the other two types of poles in the manner in which access to the camera housing is obtained. With the 200 model, the camera housing is lowered through a manual process whereas the lowering process for the other two models is automatic and similar to that of an elevator. The “elevator” poles (models 300 and 400) look and act similar to each other, with the 400 model being the most recently released model used in San Diego. Figures 4-4 and 4-5 show the position of the lowered camera housing for the hinged and elevator models respectively.

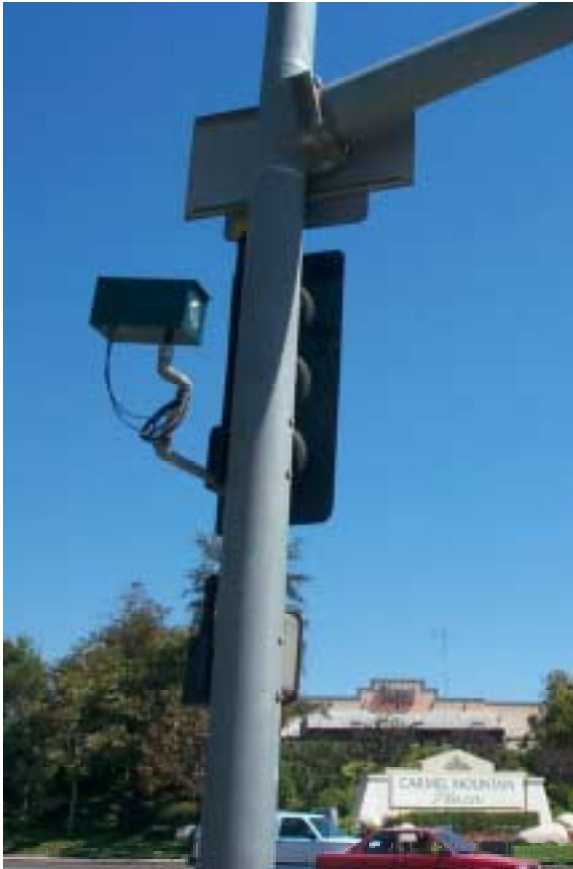
**Figure 4-6
EL 250 AUXILIARY FLASH**

An auxiliary flash(s) were installed at eight locations to help illuminate the interior cabin of the vehicle committing a red light violation (see Table 4-10). Auxiliary flashes were not installed at the other eleven intersections because either they were not needed or the intersection geometry prevented the installation of units at locations close enough to the intersection where the flash would be beneficial. In most instances, the EL 250 (250 indicates the flash's intensity in watts) model flash was used (see Figure 4-6). The exception would be the intersection of Aero Drive at Murphy Canyon Road where the EL 500 model flash was used (see Figure 4-7).

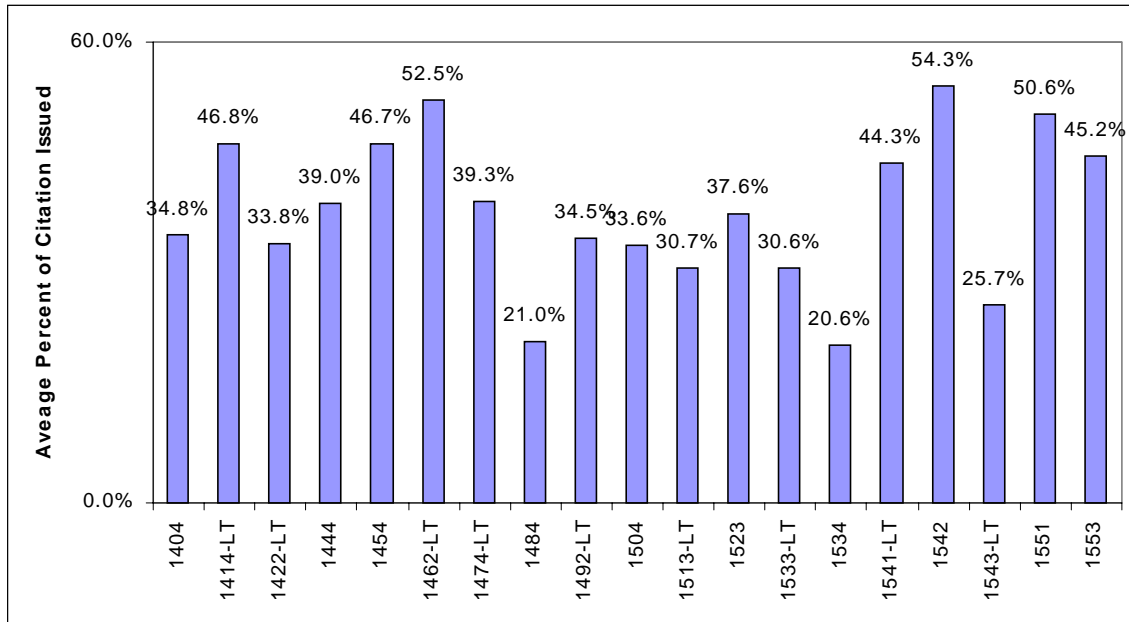
**Figure 5-2
PERCENT CITATIONS ISSUED BY INTERSECTION**

In Figure 5-2, the overall percent of recorded violations being converted to citations is presented for each of the photo-enforced locations. The percent of citations issued varies from a low level of about 21 percent for the Imperial Avenue/Euclid Street (1484) and Miramar Road/Camino Ruiz (1534) intersections to a high level of about 54 percent at the intersection of Mission Boulevard and Garnet Avenue (1542). More than 50 percent of the violations recorded at the College Avenue/Montezuma Road (1462) and Black Mountain Road/Gemini Avenue (1551) intersections are cited.

The percent of citations issued varies from a low level of about 21 percent for the Imperial Avenue/Euclid Street (1484) and Miramar Road/Camino Ruiz (1534) intersections to a high level of about 54 percent at the intersection of Mission Boulevard and Garnet Avenue (1542). More than 50 percent of the violations recorded at the College Avenue/Montezuma Road (1462) and Black Mountain Road/Gemini Avenue (1551) intersections are cited.

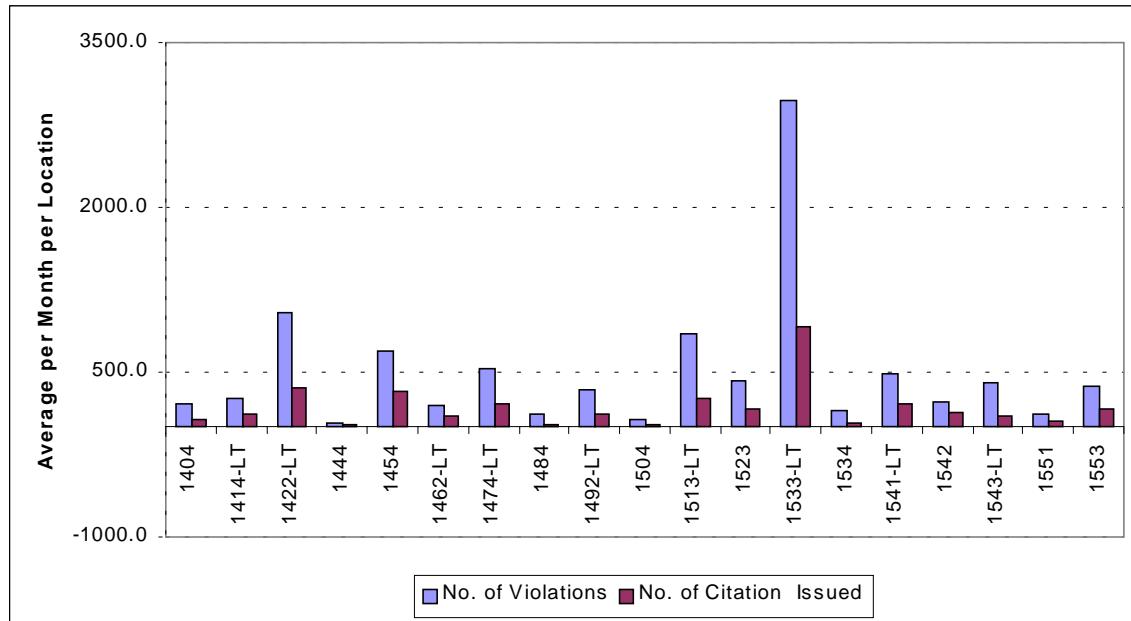
Figure 5-3
AVERAGE MONTHLY NUMBER OF VIOLATIONS AND CITATIONS ISSUED
BY PHOTO ENFORCED INTERSECTION

Figure 5-3 shows the same data for the photo-enforced intersections, but with the average monthly number of violations and citations depicted instead of the percentage of violations being cited. From this data, it is easily remarked that intersection of North Harbor Drive and Grape Street (1533) experiences a much higher incidence of red light running violations than any of the other photo enforced intersections. At this intersection, left turn violations are enforced. It may also be noted that there are very low levels of red light running at the Harbor Drive/32nd Street (1444) and F Street/Tenth Street (1504) intersections as well as moderately low levels at the Imperial Avenue/Euclid Avenue (1484), Miramar Road/Camino Ruiz (1484), and Black Mountain Road/Gemini Avenue (1551) intersections. Through red light running violations are monitored at each of these intersections where there are low levels of red light running violations.

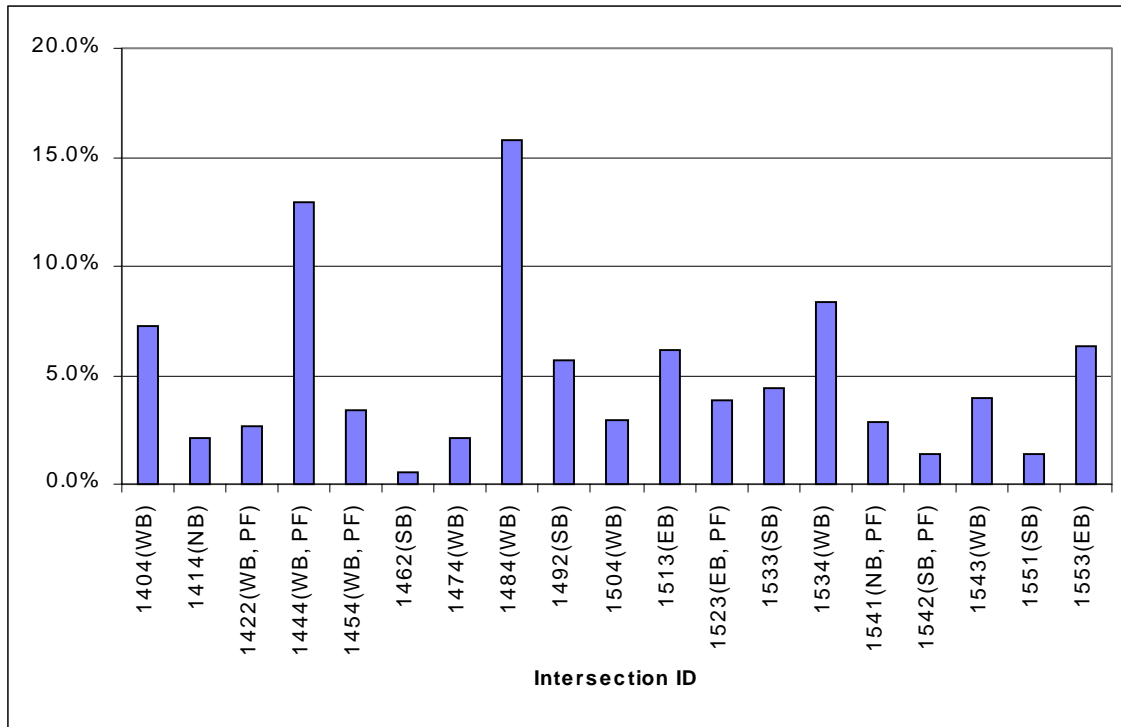
Figure 5-5
CITATIONS NOT ISSUED DUE TO DARK VEHICLE INTERIOR

The percent of citations not issued due to dark vehicle interiors and poor clarity of driver's face were analyzed. The results for these factors by intersection are highly correlated as shown in Figures 5-3 and 5-4. A total of 4.1 percent of all recorded violations could not be cited due to dark vehicle interiors. This problem results from the high degree of contrast between the vehicle interior lighting and the ambient outside lighting under strong daylight conditions. The camera exposure is adjusted automatically for the dominant ambient brightness outside the vehicle and, therefore, the interior of a vehicle tends to be under-exposed. This problem is more pronounced for vans and passenger cars with tinted windows where outside backlighting is blocked from the vehicle interior. Auxiliary flash units may be employed to mitigate the problem and reduce the number of citations not issued for this reason. The installation of auxiliary flash units at the intersections with the highest number of citations being not issued for dark vehicle interiors should be investigated.

The analysis of citations not issued for dark interiors also suggested that the problem could be related to the direction of travel being enforced. Six intersections that show higher percents of citations not issued due to dark interiors are oriented either westbound or eastbound. Cameras at four of these intersections are not equipped with polarizing filters.

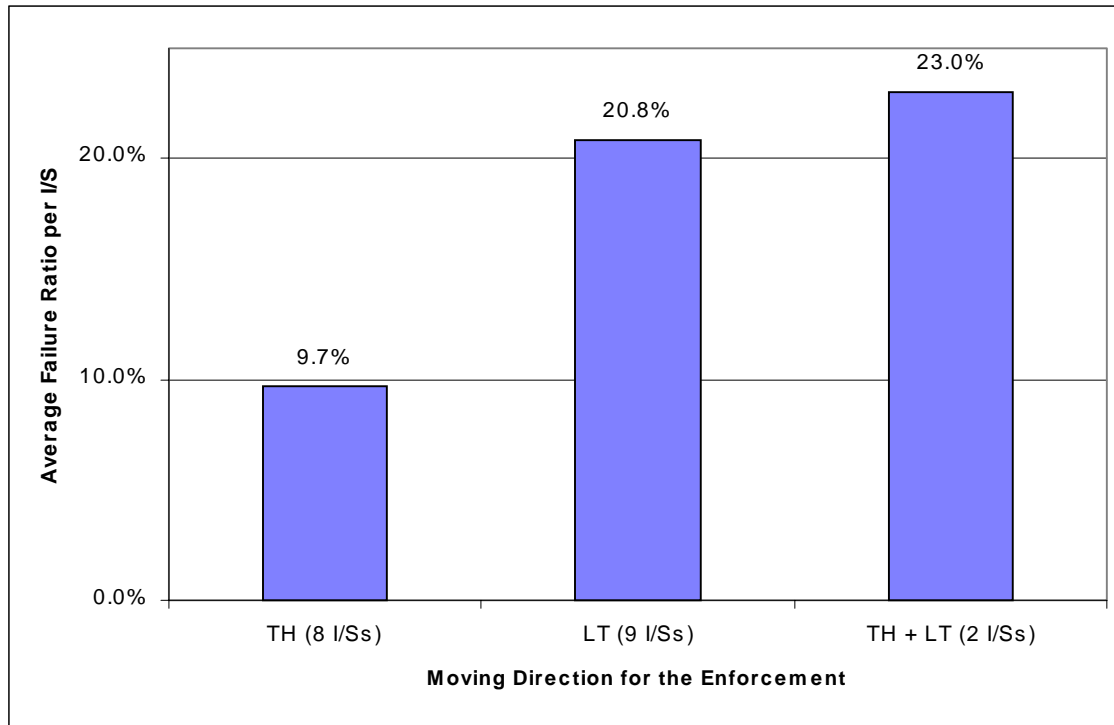
Figure 5-11
CITATIONS NOT ISSUED FOR OBSTRUCTION AND FRAMING FACTORS
BY TYPE OF ENFORCEMENT

Intersections 1422, 1533, and 1543 have experienced higher rates of citations not being issued due to framing problems. Enforcement at each of these intersections is for double left-turn lanes. For these locations, factors contributing to the higher rates of citations not issued are motorists speeding up as left turn movements are being completed (especially if being done against a red traffic signal), irregular turning movements, and a relatively shorter distance from the camera to the point where the second photograph is taken. Figure 5-8 summarizes the citations not issued data combined for obstruction and framing factors for this type of left turn lane enforcement, showing higher rates of citations not issued for left turns and left turns combined with through traffic enforcement.

Approximately 23 percent of the possible violations are not cited because the driver's face, vehicle, or license plate is out of the frame of the photograph or is obstructed. These factors are more common at intersections where double left turn lane movements are being enforced.

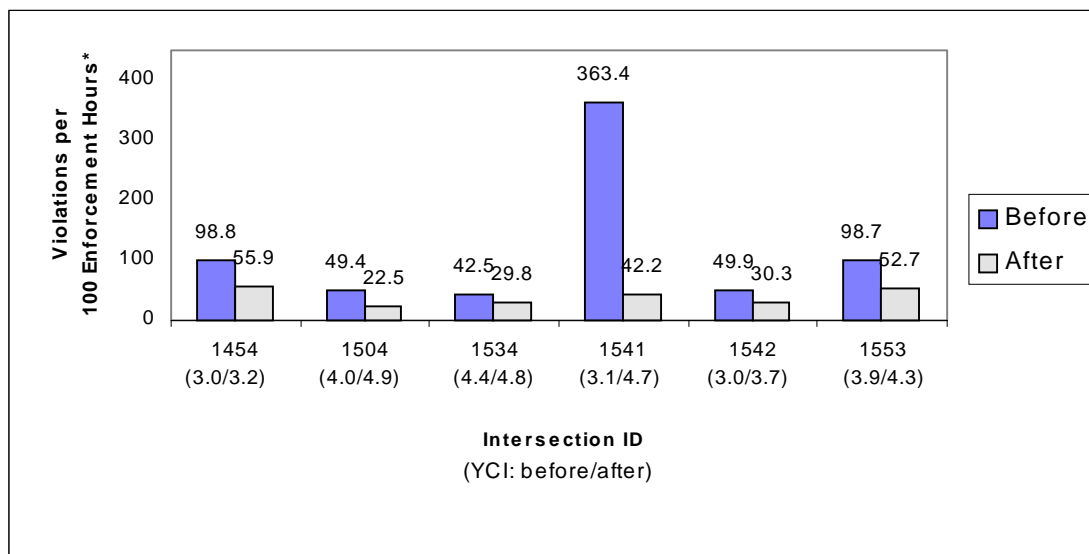
Figure 6-1
VIOLATIONS DATA FOR SELECTED PHOTO ENFORCED INTERSECTIONS
BEFORE AND AFTER YELLOW CHANGE INTERVAL MODIFICATIONS

A comparison of the numbers of red light running violations before and after the modifications in the yellow change intervals at the five photo enforced intersections confirms the findings of the Insurance Institute's research studies. The before and after violations data is shown in Figure 6-1.

The most significant change in the number of violations occurred at the intersection of Mission Bay Drive and Grand (1541) where the yellow change interval was extended from 3.1 seconds to 4.7 seconds. This change resulted in an 88-percent decrease in the number of violations. At the five other intersections, the number of violations dropped significantly in response to longer yellow times.

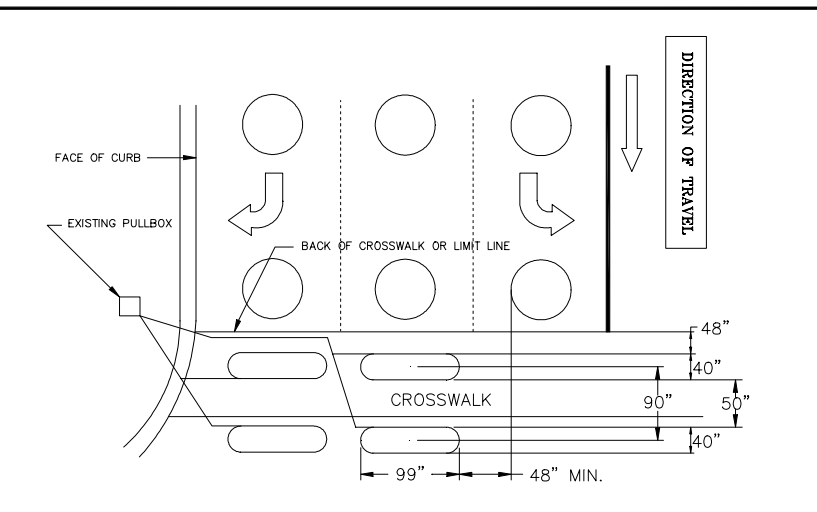
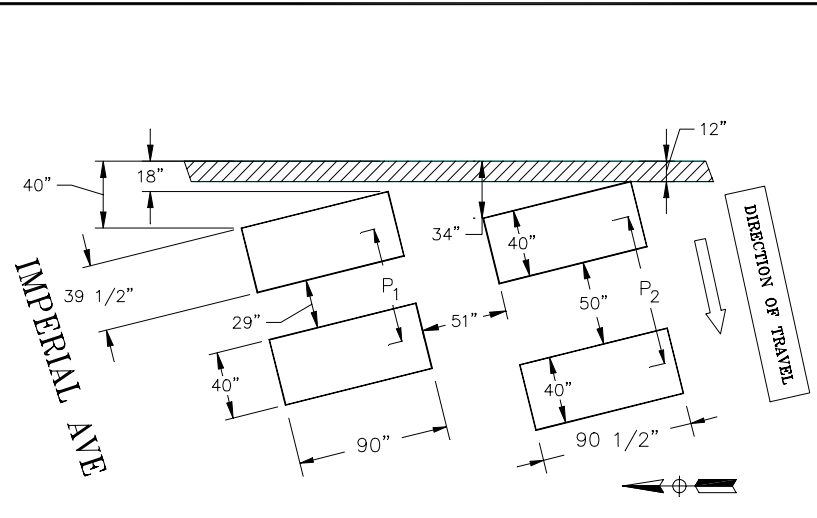
**LOOP PLACEMENT DIMENSIONS
SHOWN ON CITY PLANS
01-28-99 & REVISED 03-04-99**

**LOOP DIMENSIONS
OCTOBER, 2001
FIELD PLACEMENT**

P₁ = PITCH=68.75"/175cm
P₂ = PITCH=90"/229cm
