# **Analysis of High Collision Locations in San Leandro**

Prepared for:  
**City of San Leandro**  
Under  
**Traffic Engineering Technical Assistance Program  
(TETAP)**

**Dowling Associates, Inc.**

February 3, 2005

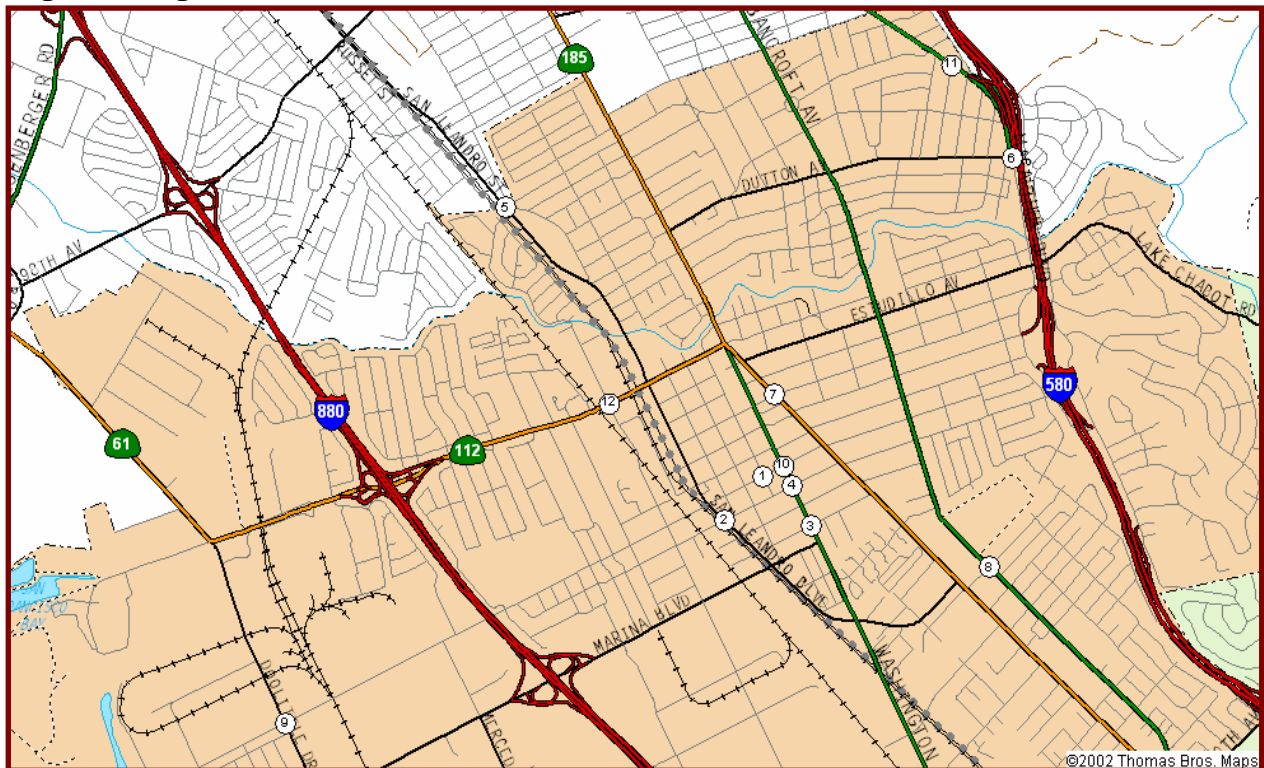
**Figure 1: High Collision Intersections**

The twelve locations with the highest collision rates concentrated in the north central region of the city as shown in Figure 1. The numbers on the map correspond to the ranking shown in Table 2. The intersections recommended for further analysis shown in bold lettering in the table.

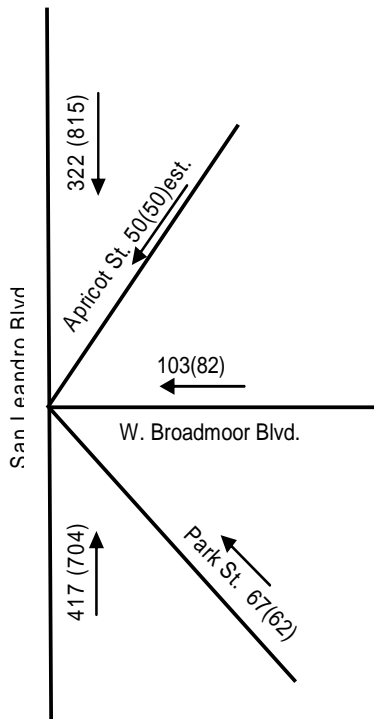
**Figure 8: AM (PM) Peak Hour Traffic Volumes**

Three minor streets converge at San Leandro Boulevard to form this intersection. One of the minor streets, Apricot Street, is located in the City of Oakland. Peak hour approach traffic counts conducting in June 2002 for the intersection is presented in Figure 8. Because approach counts and collision data for Apricot Street are not available, the presented estimates are based on adjacent street counts and observations.

The three minor streets are controlled by stop signs, while San Leandro Boulevard is uncontrolled. Vehicles on San Leandro Boulevard travel at high speed and may potentially be unaware of the intersection, which is set back slightly to the east.

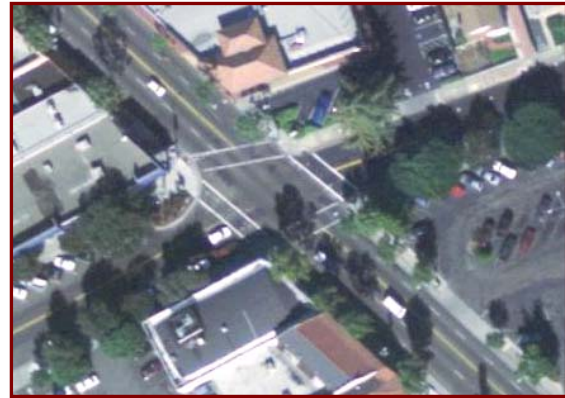
**Figure 16: Juana Avenue at E. 14<sup>th</sup> Street**

With the exception of one of the pedestrian-related incidents and two westbound vehicles colliding with southbound traffic, all the remaining collisions only involved vehicles originated from 14<sup>th</sup> Street that were either proceeding straight through the intersection (4 rear-ended collisions) or performing left-turn maneuvers (6 collisions).

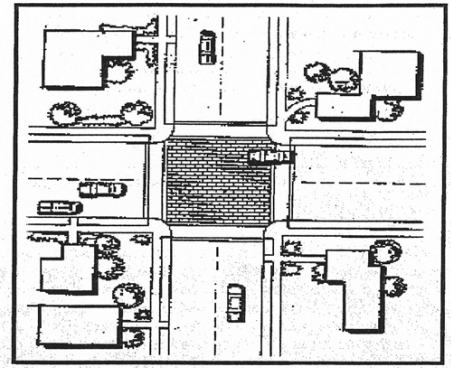
**Figure 21: Raised Table**

A major drawback of the raised table is that, even though the device would not impede access, it would slow emergency vehicles to approximately 15 miles per hour<sup>3</sup>. Such delay may not be acceptable to the City. An example of raised table is shown in Figure 21.

An alternative traffic calming device to bulb-outs is raised table, also known as raised intersection. Raised table has several advantages. It would reduce through movement speeds at the intersection as well as midblock speed. It would create a more pedestrian-friendly intersection and would signal land use transition from commercial uses to residential and school zones. It also would provide opportunity to improve aesthetic appeal and helps make the neighborhood commercial center a focal point of the area. Warning signs should be posted to alert motorists of the raised table prior to entering the intersection so that they can adjust their speed accordingly.
